# Use of sediments and soils (paleosols) in construction fills of the La Joya archaeological site, Veracruz, Mexico: micromorphological evidence

García-Zeferino, T.A., Daneels, A., Díaz-Ortega, J., Solleiro-Rebolledo, E., 2022, Use of sediments and soils (paleosols) in construction fills of the La Joya archaeological site, Veracruz, Mexico: micromorphological evidence: Boletín de la Sociedad Geológica Mexicana, 74 (3), A100422. <http://dx.doi.org/10.18268/BSGM2022v74n3a100422>

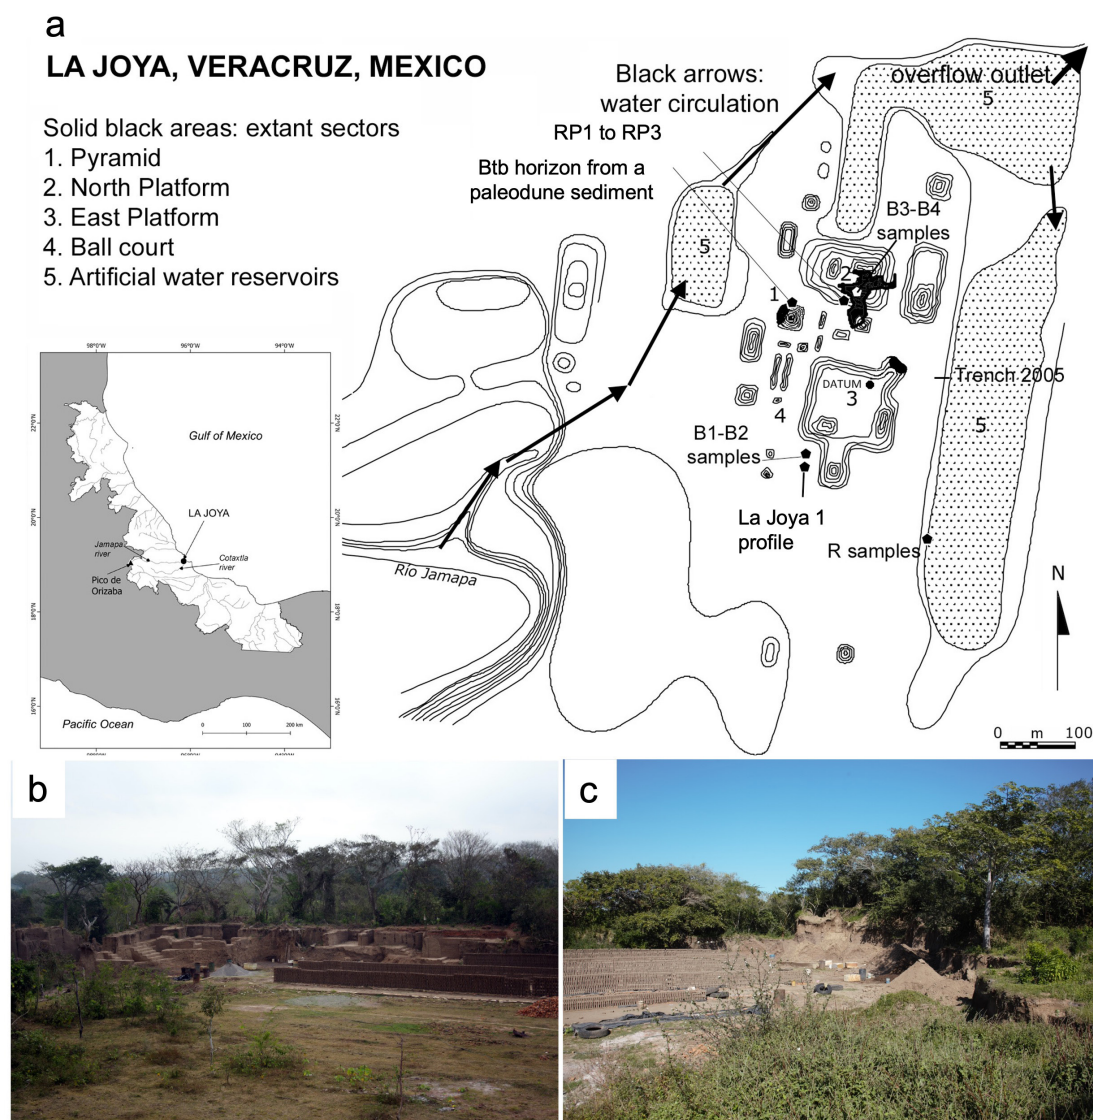
**Figure 1** a) Sketch map of La Joya, with the monumental compound (based on the 1937 sketch) surrounded by reservoirs (mapped in 2004). The level curves are drawn every 2 m. Solid black areas indicate remained sectors in 2008. Arrows indicate the water circulation pattern of the hydraulic system. Solid pentagons indicate the location of the sampling areas: natural soil in La Joya profile 1; Btb horizon developed on a paleodune sediment; the reservoir (samples R), and the fills (RP and B samples); b) photograph of the site with a view of the North Platform; c) detail of destruction of the site by the extraction of the earth to make bricks.

At the North platform (number 2 in Figure 1), the fills of the first construction stage were analyzed (Figure 2). These fills (samples RP1- RP3) are below 90 cm of a later construction fill and rest directly on a buried ABb horizon. The three fills are similar: they have brownish colors, a clayey silty texture, they are compact and show a subangular blocky structure. Differences are observed in the amount of artifacts, being abundant in the upper fills (RP1 and RP2) and decreasing in the lower fill (RP3).

At the western edge of the East reservoir (number 5 in Figure 1a), a profile was exposed during recent land works. The size of the East reservoir is 500x75x2 m, totaling a volume of at least 75,000

The natural profile (La Joya profile 1) is located immediately southwards from the profile where the B1 and B2 samples were obtained (Figure 1a) and has a total depth of 3.40 m (Figure 5), however the first 1.70 m corresponds to a soil formed in a sediment, as part of the 2 m fill placed over the surface during the third building stage; it contains abundant ceramics from the Middle and initial Late Classic (AD 400 and 700). At 1.90 m, a polycyclic paleosol is found. It has Aib, ABib1, 2ABb2, 2Btb3, 2Btgb4, 2BCb5, 2Cb6 horizons (Figure 5). The Aib and ABib1 horizons are dark brown with an angular blocky structure and a loamy texture. The uppermost Aib horizon is thin probably due to natural erosion or because of anthropic remotion. The 2ABb2 horizon is reddish brown, slightly more clayey; it has a subangular blocky

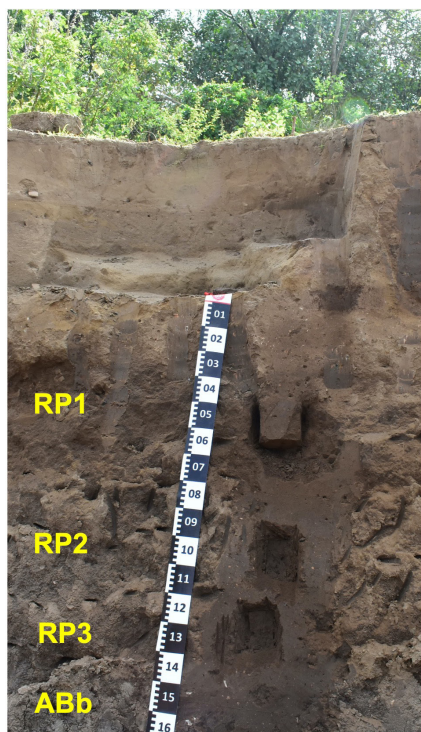
**Fill of a later construction fill**

| Fill | Depth (m) | Description |
| RP1 | 0.90-1.10 | Dark brown, sandy loam texture. Subangular blocky structure, compact. Abundant artifacts. |
| RP2 | 1.10-1.50 | Brown, loam texture. Subangular blocky structure, compact. Abundant artifacts. |
| RP3 | 1.50-2.00 | Brown, loam texture. Subangular blocky structure, compact. Less amount of artifacts. |
| ABb | >2.00 | Dark brown, clayey-loam texture. Subangular blocky structure, compact. Fine roots and vesicular pores. Abundant artifacts (charcoal, ceramic, bones). |

**Figure 2** Fills from the first construction stage at the North platform.

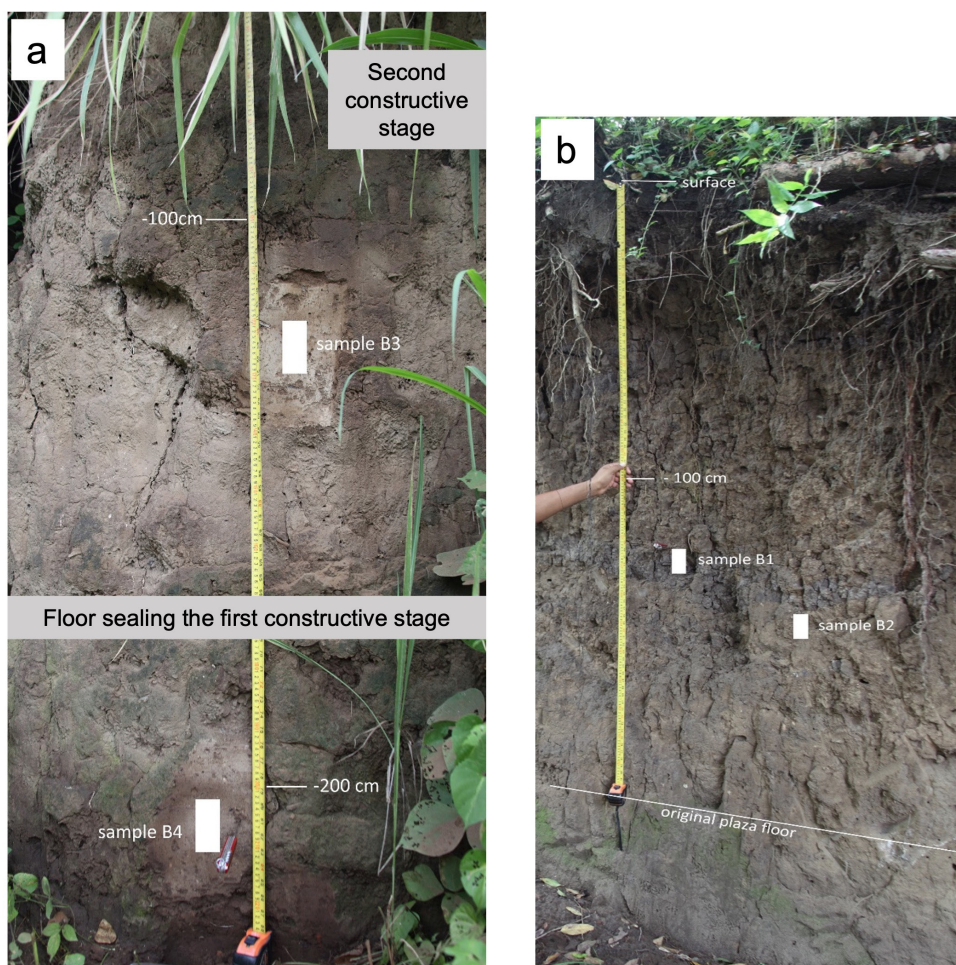
**Figure 3** Fills of: a. first and second construction stages, at the North platform; b. third construction stage, at the Plaza area.

Also in the North Platform, we sampled another building of the first and second construction stages (Figure 3a). The first building fill consists of a dark sandy loam with abundant charcoal flecks, sherds, obsidian, and animal bones. Sample B4 was taken from this layer, at 205 to 210 cm below modern surface and 40 cm below the floor sealing the first

building stage fill, at 8.25 m below datum (Figure 3a). The earth from the second stage building is a light brown loam, with very few sherds. Sample B3 was taken from the fill of the platform supporting the so-called audience hall, a building used for special assembly purposes (Figure 1a), 120 to 125 cm below modern surface, and 35 cm above the floor of the first building stage, at -7.50 m below datum. The samples of the third building stage come from the fill of the plaza area to the West of the East Platform (labeled 3 in Figure 1a), about 350 m to the south of the pyramid (labeled 1 in Figure 1a). This fill contains sand mixed with clayey blocks of gray sediments, from which B1 and B2 samples were taken (Figure 3b), 120 to 140 cm below modern surface, and 80 cm above the plaza floor placed during the second building stage. Sample B1 is greyish and clayey, while sample B2 is a yellowish sand.

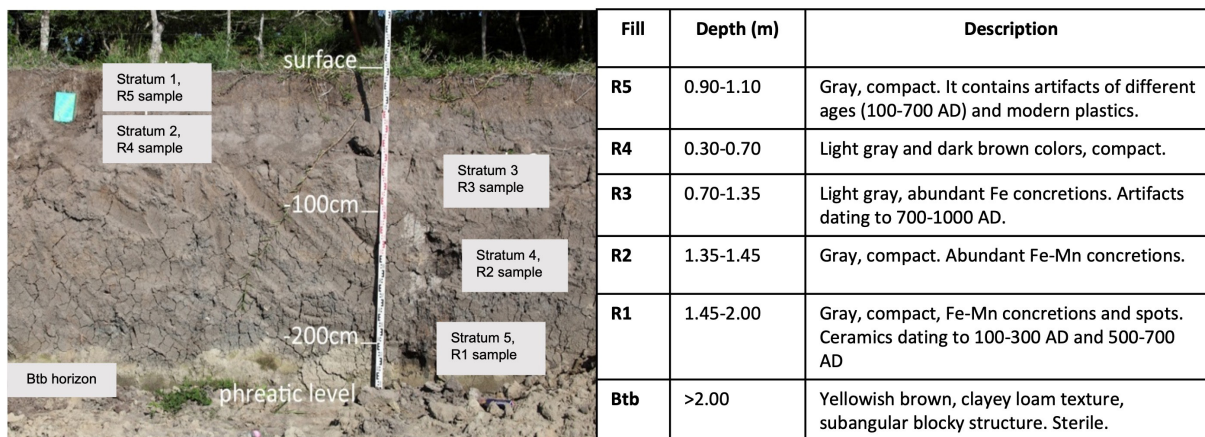
Figure 4 Materials of the reservoir, showing in the bottom the Btb horizon of the natural surface.

m<sup>3</sup>; presently it is silted in and used as dry season cattle pasture, holding water only during the summer rains or major river floods. The profile measures 2.30 m from surface to phreatic level and consists of 6 strata (Figure 4). The one at the bottom is a sterile yellow sandy clay layer which corresponds to a Btb horizon formed from a paleodune sediment, apparently 30 cm above the phreatic level. Overlying the Btb horizon, a horizontal blue-gray layer, 65 cm thick, with some iron oxide concretions is observed (Sample R1). Directly on top of this stratum, there are two layers of large sherds, lying horizontally. The first one contains ceramic types dating to AD 100-300, and halfway up, while the second one has smaller sherds of types dating to AD 500-700. Above them, there

is a thin horizontal layer of yellow gray gley, 10 cm thick (stratum 4- sample R2), very similar to the stratum 5 but with abundant iron concretions. The stratum 3 (sample R3) is a 55 cm thick-horizontal layer of light blue gray gley with abundant iron concretions dispersed in the stratum. We observe small sherds of ceramic types dating to AD 700-1000 as well as daub fragments, possibly of burnt roofs. Overlying this layer, a change is clearly observed, as the 40 cm thick-stratum 2 has dark brown colors (sample R4). It has clayey loam texture, with few sherds.

At the top of the sequence the stratum 1 (sample R5) is again a layer of gray gley with large iron oxide concretions, with some sherds of AD 100-700 types mixed with modern plastic garbage.

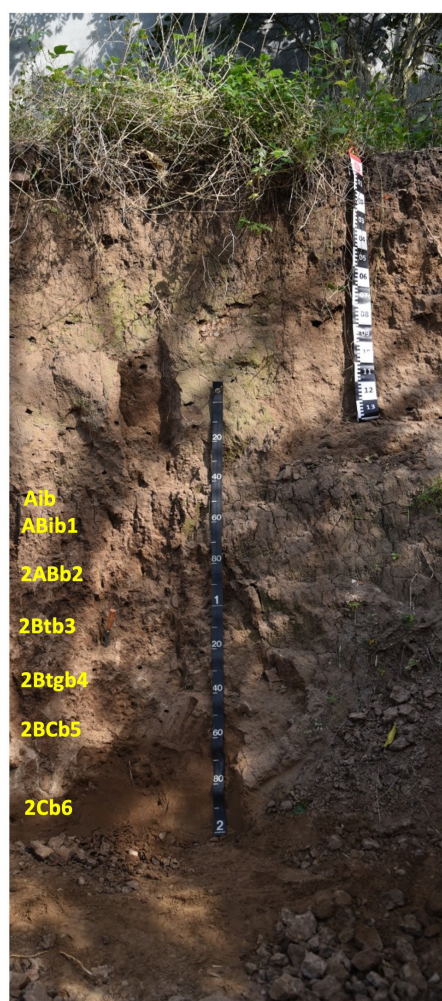
### Soil formed from sediments accumulated from past and recent human activities

| Horizon | Depth (m) | Description |
| Aib | 1.70-1.75 | Dark color, granular-angular blocky structure, clayey sand. Fine roots. Vertical fractures. Vertic features. |
| ABib1 | 1.75-2.05 | Brown, angular blocky structure, vertic features, clayey sand, ceramic fragments. Fine roots. |
| 2ABb2 | 2.05-2.30 | Reddish brown, subangular blocky structure, clayey loam, ceramic fragments. |
| 2Btb3 | 2.30-2.70 | Reddish brown, subangular blocky structure, clayey loam, ceramic fragments. Clay coating on ped surfaces. |
| 2Btgb4 | 2.70-3.00 | Reddish brown, subangular blocky structure, clayey sand. Clay coating on ped surfaces. |
| 2BCb5 | 3.00-3.20 | Dark brown, subangular blocky structure, clayey loam. |
| 2Cb6 | 3.20-3.50 | Light brown, structureless, sandy. |

**Figure 5** Natural soil profile (La Joya profile 1) showing the modern soil and the buried polycyclic paleosol.

structure. The 2Bt horizons (2Btb3 and 2Btgb4) are reddish brown. They have a loamy texture and a subangular blocky structure. Thin clay coatings and Fe-Mn nodules and mottles are visible with a 10X-lens. The lowermost horizons are brownish and yellowish. They are more sandy and less structured. Vertical fractures are observable, which enter down the profile, evidencing vertic features. Ceramic fragments are also seen along the profile, however, they can be the result of vertical transportation along the vertical fractures, as they are mainly found along them, sometimes together with modern materials from the surface, or from the activities of modern brick workers, active at this level of the profile.

The ABib1 horizon of the natural profile excavated in the south of the main pyramid (Figure 5) shows a dark groundmass where angular blocks are clearly defined (Figure 10e). The Bt horizons in this profile (2Btb3, 2Btgb4) shows two generations of undisturbed clay coatings of strong birefringence: one with a reddish color and another with a yellowish color (Figure 10f and 10g). In the 2Btgb4, there are abundant redoximorphic features as single Fe nodules, complex Fe nodules (Figure 10h) and Fe coatings (Figure 10h). The 2Cb6 horizon shows the presence of sand grains with different degrees of alteration. They consist of plagioclases, rock fragments, pyroxenes, and quartz (Figure 10i). The horizon has a granostriated b-fabric with thin clay coatings around the minerals (Figure 10i).

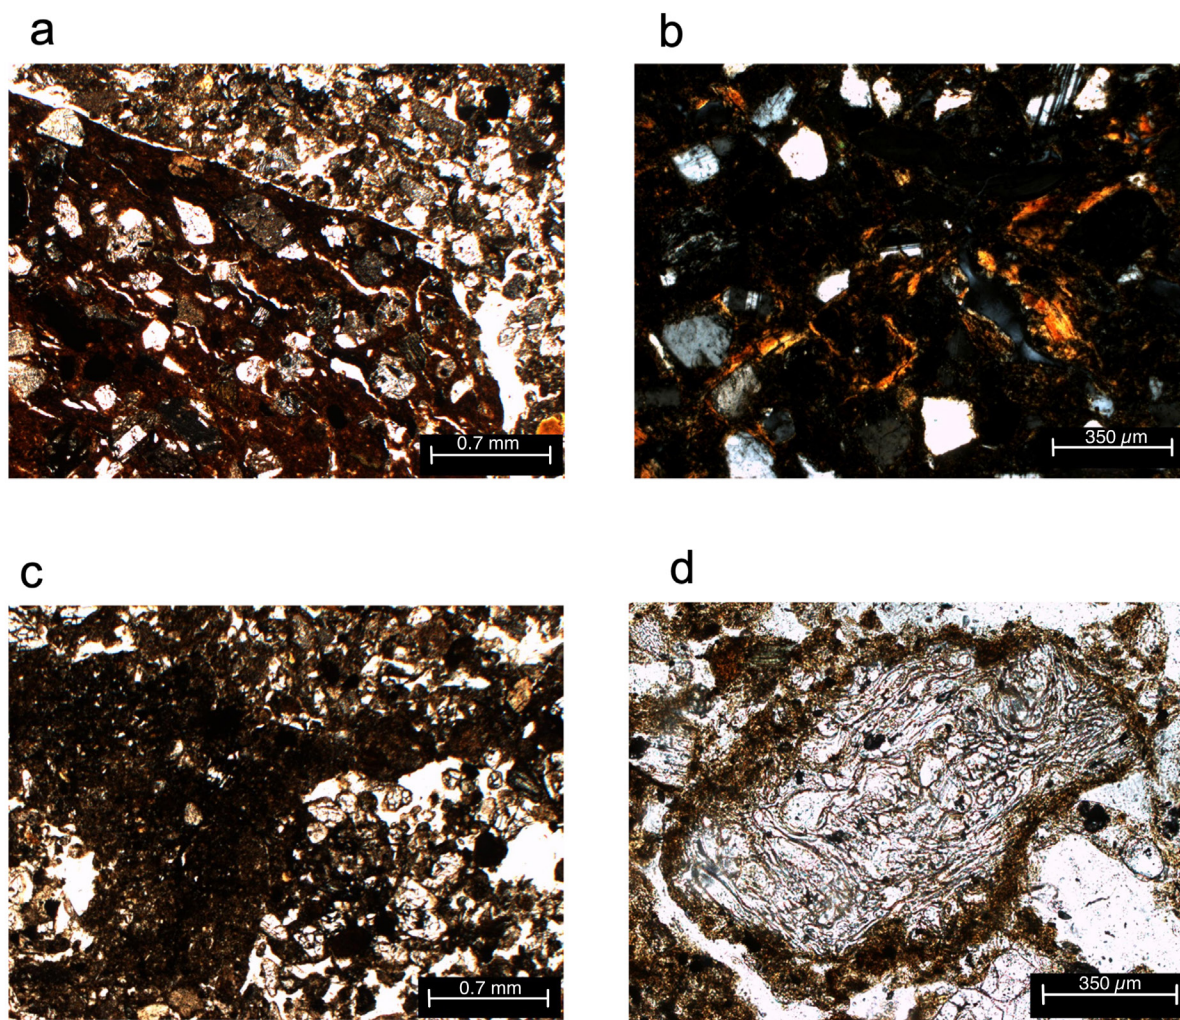
**Figure 6** Micromorphology of the fills of the first construction stage: a. ceramic fragment where volcanic materials are observed in RP1, plane-polarized light (PPL); b. illuvial clay coatings from a soil fragment in RP1, cross polarized light (XPL); c. dark soil fragment, crushed and compacted in RP2 (PPL); rounded Fe concretions are observed in the dark groundmass; d. volcanic glass fragment in a sand groundmass in RP2 (PPL).

pieces of ceramic where volcanic components are identified (Figure 6a, RP1); fragments of soils where oriented clay coatings are visible (Figure 6b, RP1) as well as Fe nodules (Figure 6c, RP2). Some areas present soil fragments that are crushed and pressed, consequently they have abrupt boundaries with the groundmass (Figure 6c). Unweathered volcanic glass particles are also found (Figure 6d, RP2).

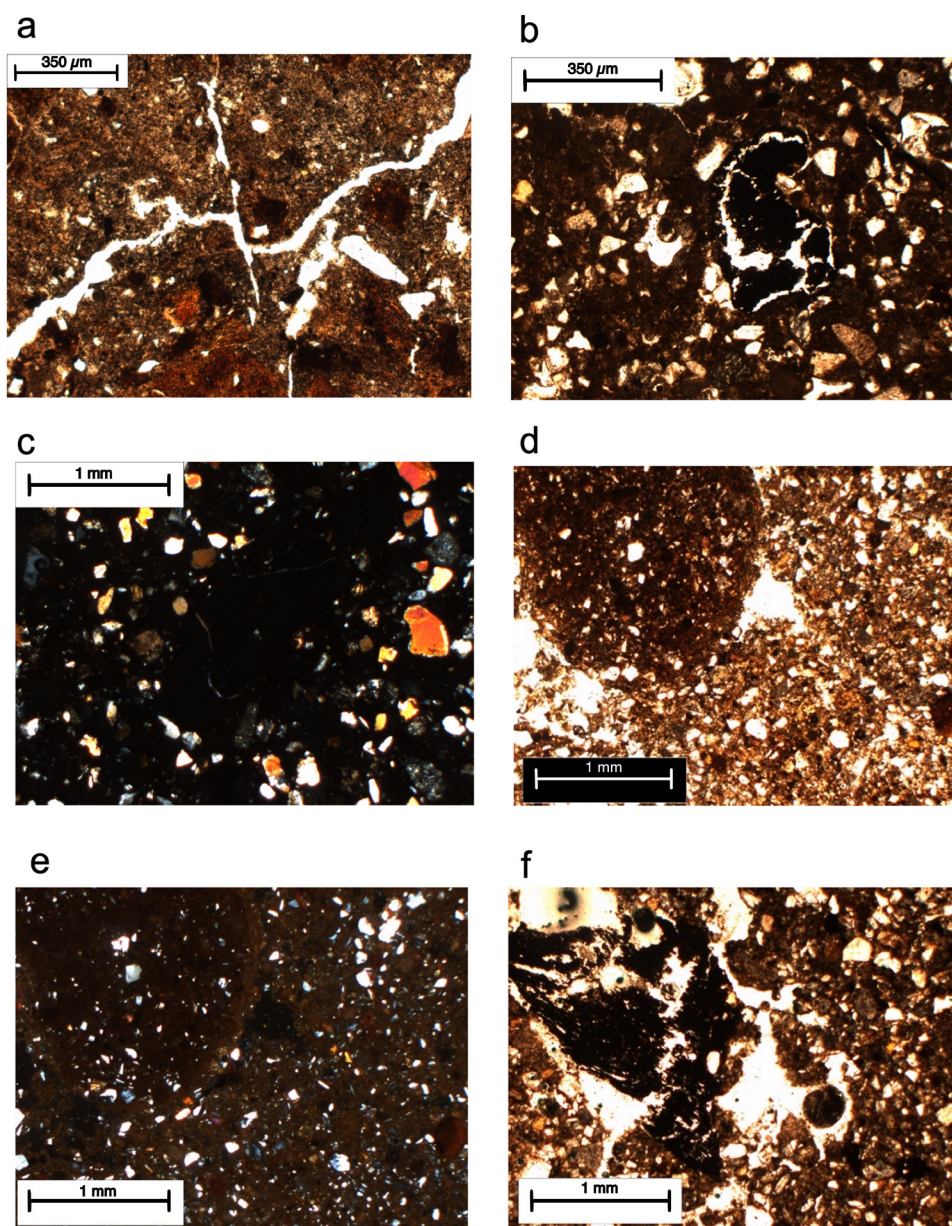
**Figure 7** Micromorphology of the fills of the first and second construction stages at North platform. B4 sample: a. subangular blocky structure (PPL); b. Obsidian flakes and charcoal (PPL); c. Re-worked, fragmented clay coatings in a sandy groundmass (XPL); B3 sample: d. rounded fragments made up fine sand in a fine sand groundmass with dark spots of Fe-oxides (PPL); e. same as d, (XPL); f. porous areas with charcoal and Fe oxides nodules (XPL).

Sample B4, obtained from the North Platform (first stage of construction) has a subangular blocky structure (Figure 7a) with sand grains, mainly constituted by quartz, plagioclases and pyroxenes (Figure 7a). There are abundant anthropic artifacts, like obsidian flakes (Figure 7b), ceramics and charcoal (Figure 7b) as well as reworked clay

coatings (Figure 7a and 7c). Sample B3 (second building stage) is massive (Figure 7d).

The groundmass is reddish brown, impregnated with iron oxides (Figure 7d) containing reworked clay coatings. High amounts of fine sand are observed (Figure 7d and 7e) composed mainly by quartz with some content of pyroxenes, and plagioclases. There are also rounded dark aggregates incorporated in the lighter groundmass (Figure 7d and 7e) and porous areas where charcoal fragments are present (Figure 7f).

When we compare the micromorphological characteristics of the RP1, RP2 and RP3 samples, from the North Platform, representing the first building stage, there are interesting features: the material found in the RP2 is like the ABb horizon of the natural soil, where dark granules are visible (Figure 10c), but in the case of the fill, the material has been crushed and compacted (Figure 6c) and mixed with volcanic materials, which look mostly fresh (Figure 6d) and with fragments of the Btb horizon, identified by the presence of illuvial clay coatings (Figure 6b). This kind of fill is known as structured fill, where sediments of different textures are layered in order to increase the structural stability of the construction (Daneels *et al.*, 2018). The sample B4, also from the North Platform, has similar characteristics of the Btb and Btgb horizons: it has a subangular blocky structure, like the one observed in the natural horizon (Figure 7a, 10a, 10e), reworked clay coatings (Figure 7a, 7c) as well as reddish areas impregnated with iron oxides (Figure 7d).

The B3 sample features differ from the Btb horizon of the paleosol. In the fill, the sand grains are finer (Figures 7d, 7e) with charcoal fragments (Figure 7f). There are also rounded dark fragments of fine texture, rich in quartz (Figure 7d) that are not present in the paleosol samples. The source of this material is not clear but can be related to sediments from the neighboring coastal areas of Veracruz, which contain less amount of lithics and higher content of quartz (Armstrong-Altrin *et al.*, 2015).

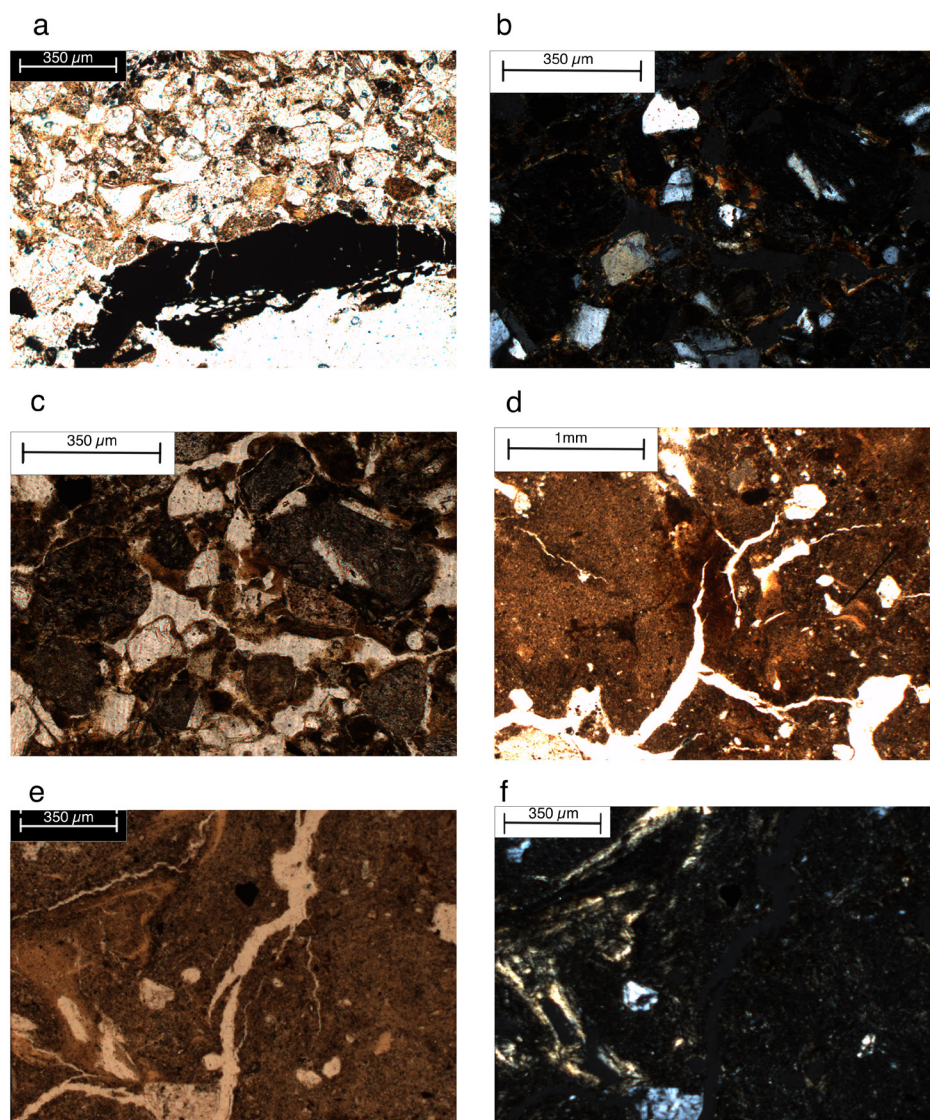
**Figure 8** Micromorphology of the third construction stage. B2 sample: sandy groundmass with a granostriated b-fabric with charcoal fragments (PPL); b. soil fragments with clay coatings in a sandy groundmass (XPL); B1 sample: c. compact soil fragments in a sandy groundmass (PPL); d. compact soil aggregates with a subangular blocky structure, with clay coatings; e. compact clayey aggregates with dirty and deformed clay coatings (PPL); f. same as e, with XPL.

The B1 and B2 samples come from the third building stage fill. The B2 sample has a massive to subangular blocky structure with abundant pores and fractures. The groundmass is sandy (Figure 8a) with particles averaging 0.14 mm; fine clayey

material exhibits a granostriated b-fabric (Figure 8a). The thin section also shows the presence of root fragments, charcoal (Figure 8a) and soil fragments where clay coatings are clearly observed (Figure 8b, c). The B1 sample is more clayey and has an angular blocky structure with planar voids and fissures (Figure 8d), fragmented clay coatings (Figure 8d), fine sand lenses and small sherd fragments. The average size of the sand particles is 0.12 mm in diameter. Another common feature is the presence of deformed and impure clay coatings (Figure 8e and 8f). The samples from the reservoir have the following features: R1 sample, at the bottom of the reservoir, has a clayey

The fills of the third construction stage at the plaza area have common micromorphological features with the paleosol. Nevertheless, the B1 sample has a coarser texture with a granostriated b-fabric (Figure 8a) and looks like the 2Cb6 horizon of the natural soil (Figure 10i), but the fill has charcoal fragments (Figure 8a). The B2 sample is more clayey with compact aggregates (Figure 8d) where clay illuvial coatings are clearly observed that relates this material to the Btb horizons of the natural soil. In addition, the fill has abundant material of anthropic origin: sherds, obsidian, and charcoal. As some features are also similar to the earth of the reservoirs (presence of compact clay, impure and deformed clay coatings, planar voids and fissures Figure 9d, 9e), we suggest that the sediment from the reservoir was used during the third construction stage; this supports the archaeological observations that some fill material was extracted from this area.

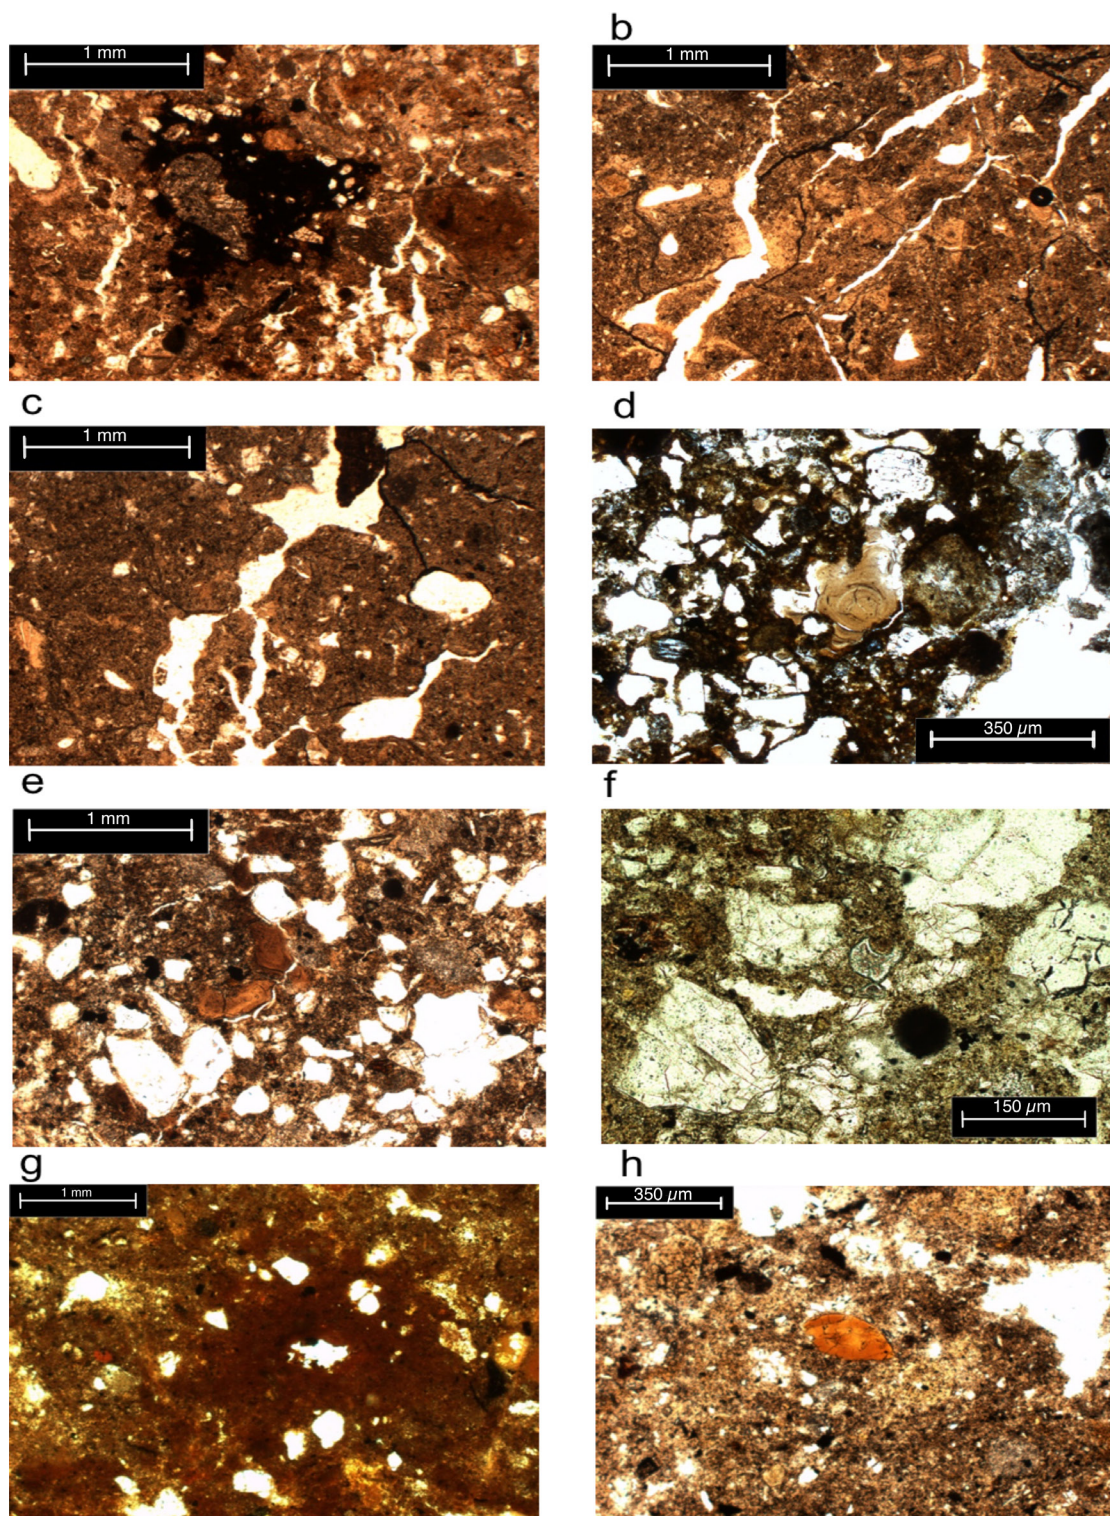
**Figure 9** Micromorphology of the reservoir. a. R1 sample clayey groundmass with planar voids and Fe-Mn complex nodules (PPL); R2 sample: b. subangular blocky structure with planar voids, fissures, and elongated pores (PPL); c. dusty clay coatings, weakly oriented (PPL); R3 sample: d. sandy and poorly structured groundmass (PPL); e. rounded soil aggregates, having thick clay coatings (PPL); R4 sample: f. coarse texture with subangular mineral grains (PPL); g. sand particles are floating in a silty-clay groundmass (PPL). R5 sample: h. compact and clayey groundmass, impregnated with Fe; areas with coarser textures where fragmented clay coatings are present (PPL).

groundmass with planar voids (Figure 9a). Some areas have lighter colors, that together with the presence of Fe-Mn complex nodules (Figure 9a) indicate redoximorphic characteristics.

The overlying stratum (sample R2) is more clayey, with a subangular blocky structure (Figure 9b). Abundant planar voids and fissures, together with elongated pores are observed (Figure 9b). In this layer, Fe nodules are also detected. Additionally, dusty clay coatings are present, which are weakly oriented (Figure 9c).

Sample R3, from the stratum 3, is more sandy and poorly structured (Figure 9d). The particles are mostly subrounded and are mainly consti-

tuted by volcanic rock fragments and plagioclases. Rounded soil aggregates, having thick clay coatings, some of them fragmented, are also present (Figure 9e). The sample R4, located near the surface, has also a coarse texture and is less compact (Figure 9f). The sand particles are floating in a silty-clay groundmass (Figure 9f). The coarse

components include volcanic glass and fragments of ceramic. In contrast, the uppermost stratum, sample R5, is highly compact (Figure 9g). The groundmass is composed by reddish clay with few biogenic pores, and a high content of iron mottles with diffuse limits (Figure 9g). The sand mineral particles are subrounded. Although the general

appearance is clayey and compact, there are areas with coarser textures where fragmented clay coatings are observed (Figure 9h).

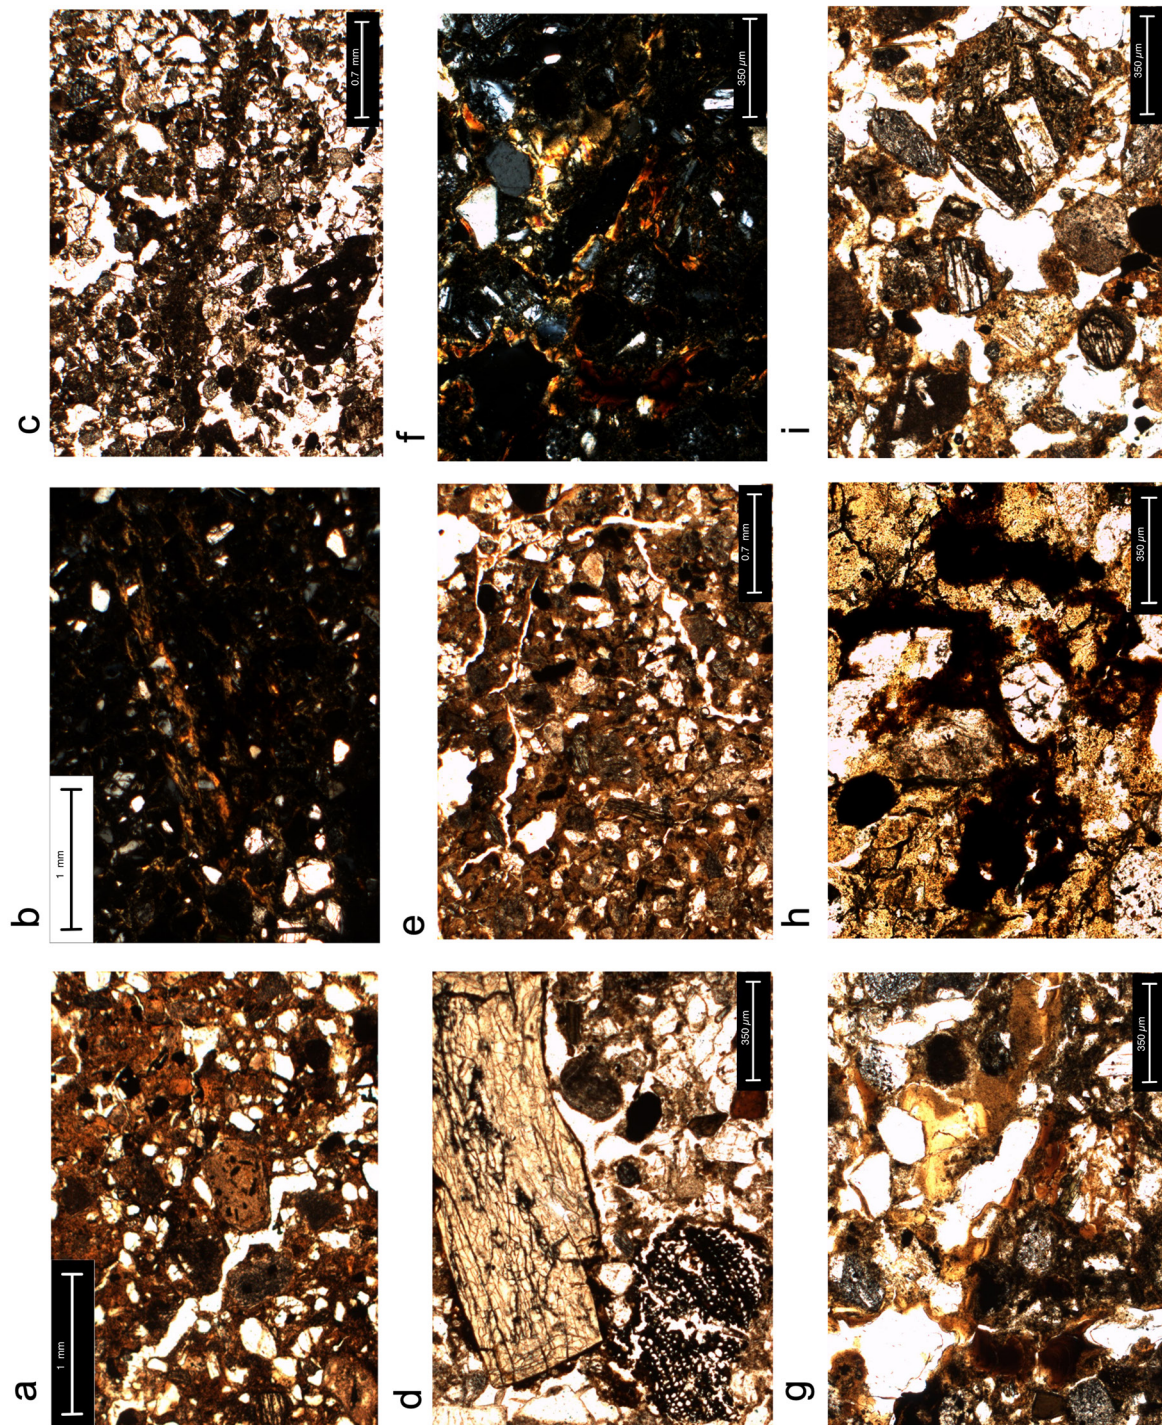
**Figure 10** Micromorphology of the natural paleosols: a. Btb horizon under the earthen constructions, showing a subangular blocky structure with planar fractures and fragments of andesite (PPL); b. illuvial clay coatings in the Btb horizon (XPL); c. ABb horizon showing a dark groundmass where fine particles are aligned and deformed (PPL); d. bone and charcoal fragments in the ABb horizon (PPL); e. angular blocky structure of the ABib1 horizon (PPL); f. two generations of in situ clay coatings of strong birefringence: one with a reddish color and another with a yellowish color in the 2Btb3 horizon (XPL); g. two generations of clay coatings accompanied by Fe oxides nodules and accumulations in the 2Btgb4 (PPL); h. altered sand grains with complex and single Fe nodules (PPL); i. plagioclases, volcanic rock fragments covered by thin clay coatings (PPL).

Micromorphology of the Btb horizon of the (decapitated) paleosol underlying all the earthen constructions, shows a subangular blocky struc-

ture with planar fractures (Figure 10a). The coarse particles include rock fragments of andesite, plagioclase, pyroxenes, micas, and some amphiboles; their average size is 0.15 mm in diameter (Figure 10a and 10b). Thick in situ clay coatings are clearly observed (Figure 10b). At the bottom of the fills in the North Platform, the buried ABb horizon shows fine sand and silt particles, impregnated with organic matter (Figure 10c). The fine particles are aligned and deformed (Figure 10c),

evidencing crushing and compaction of the material. In this horizon, we also observed bone and charcoal fragments (Figure 10d).

2Btb3, 2Btgb4, 2BCb5, 2Cb6) is characterized to show a reddish-brown color, with a high amount of sand, but with an evident increase of clay in the 2ABb2 and in the 2Btb3 and 2Btgb4 horizons (García-Zeferino, 2020), contrasting to the dominance of sand fraction in the 2Cb6 horizon, what suggests the clay has been formed by pedogenesis. Thin sections support this suggestion as thick in situ clay coatings are observed in the Bt horizons of the buried paleosol (Figures 10b, 10f and 10g). Even more, in this paleosol, different generations of clay coatings are identified, which are related to a long time of landscape stability, necessary to firstly, form the clay from the sand (parent material from the paleodune), secondly to illuviate the clay along the profile. Studies of soil formation on dune sediments indicate a long-time span for the formation of Bt horizons (Phillips, 2007). The coatings reduce the soil porosity, producing redoximorphic conditions (Buurman *et al.*, 1998), which are observed in form of Fe-Mn segregations and concretions (Figures 10g, 10h and 10i). In contrast, the micromorphology of weakly developed soils on sandy sediments in different parts of the world show the presence of fresh single grains only impregnated with organic matter or a microstructure of intergrain micro-aggregate (Hinojosa *et al.*, 2015; Stoops *et al.*, 2020). This kind of microstructures is seen in the 2Cb6 horizon (Figure 10i).

these horizons show evidence of human use, as compaction (Figure 10c) and a high amount of artifacts as charcoal and bones mixed with the natural components (Figure 10d). This observation is supported by the archaeological findings which indicate the site was occupied for almost a millennium, prior the development of the earthen structures (Daneels and Guerrero-Baca, 2011).

that the source for these strata is the paleosol affected by the water of the reservoir. The third stratum (sample R3) has a coarser texture. The sand grains are surrounded by dusty clay mixed with limpid clay fragments (Figure 9d). Its mineralogy (volcanic rock fragments and plagioclases) and grain size indicate this material proceeds from the 2BCb5 and 2Cb6 horizons of the paleosol (Figure 10h, 10i).
